Service Bulletins

iPod Nano Replacement

EFI Update for Mac Pro and Xserve 2009

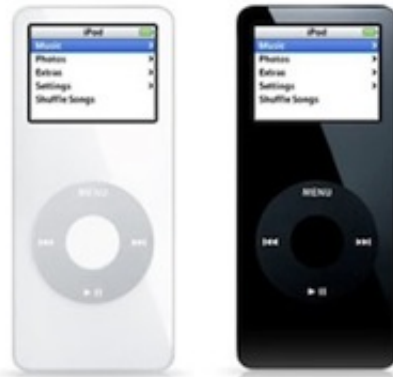
Apple has determined that, in very rare cases, the battery in the iPod nano (1st generation) may overheat and pose a safety risk. Affected iPod nanos were sold between September 2005 and December 2006.

This issue has been traced to a single battery supplier that produced batteries with a manufacturing defect. While the possibility of an incident is rare, the likelihood increases as the battery ages.
